Radial Turbine Performance Measurement Under Extreme Off-Design Conditions

Abstract

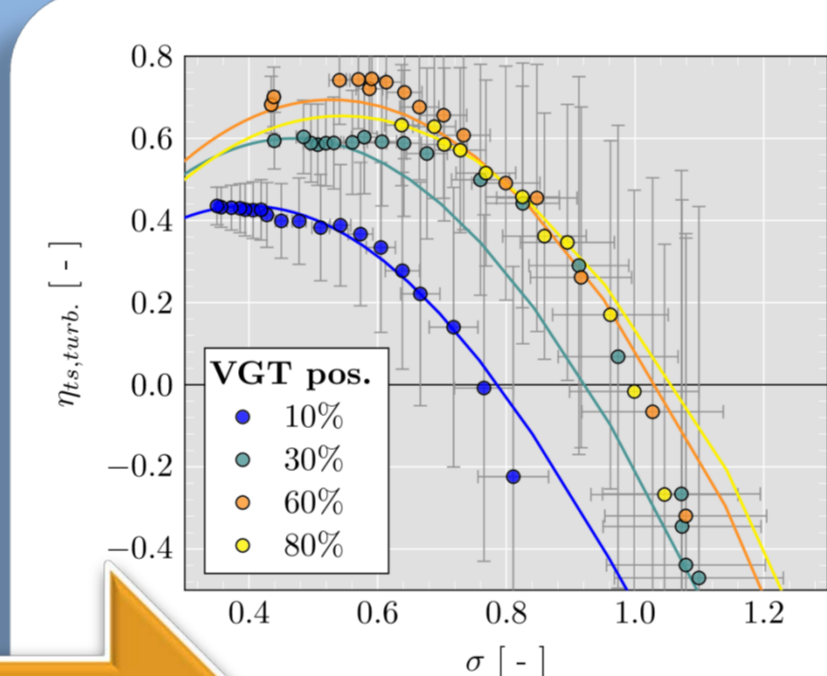
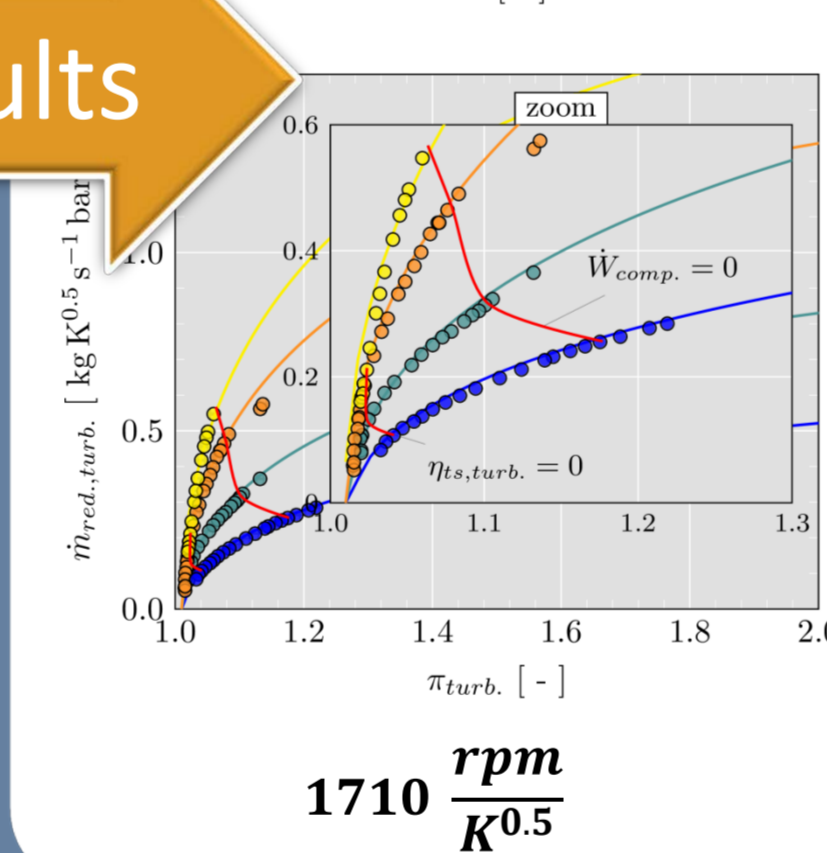
Results

Limitation: Rising the rotational speed, choking inside of the compressor volute and diffuser has taken place. Further setup modifications have been needed to measure at higher speeds.

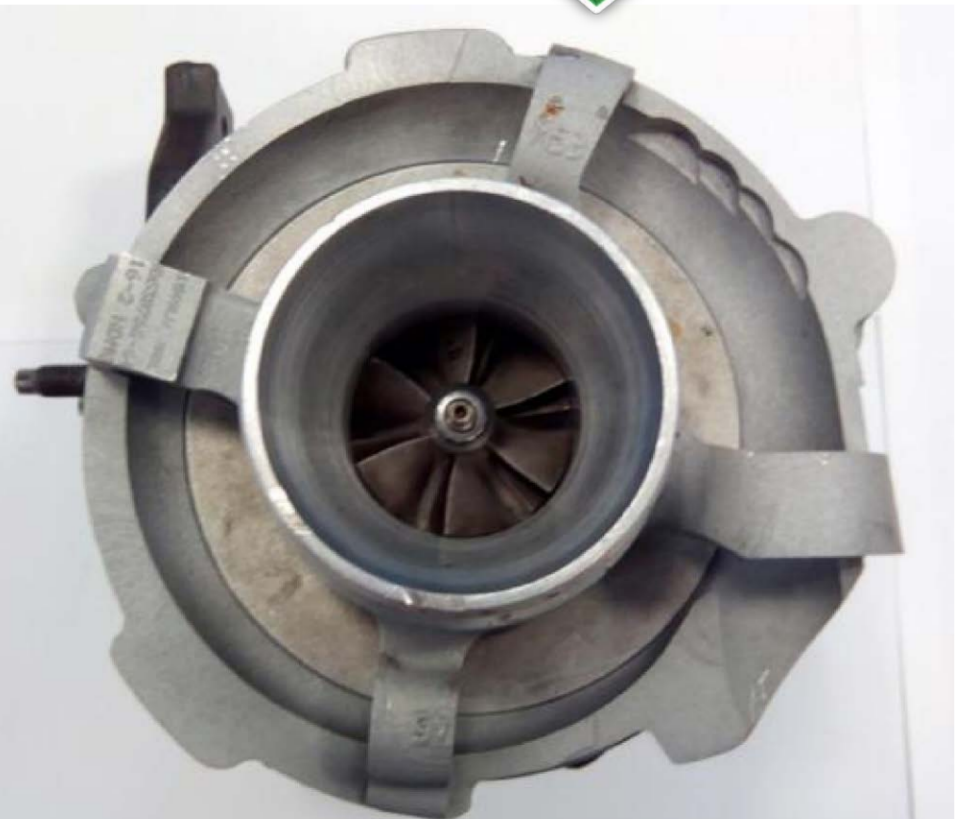
rpm
4890
K^{0.5}

The choking appears inside of the volute and diffuser since the area ratios are not designed for the existing pressure ratios. Hence, this limitation can be overcome by milling the compressor casing as shown on the left.

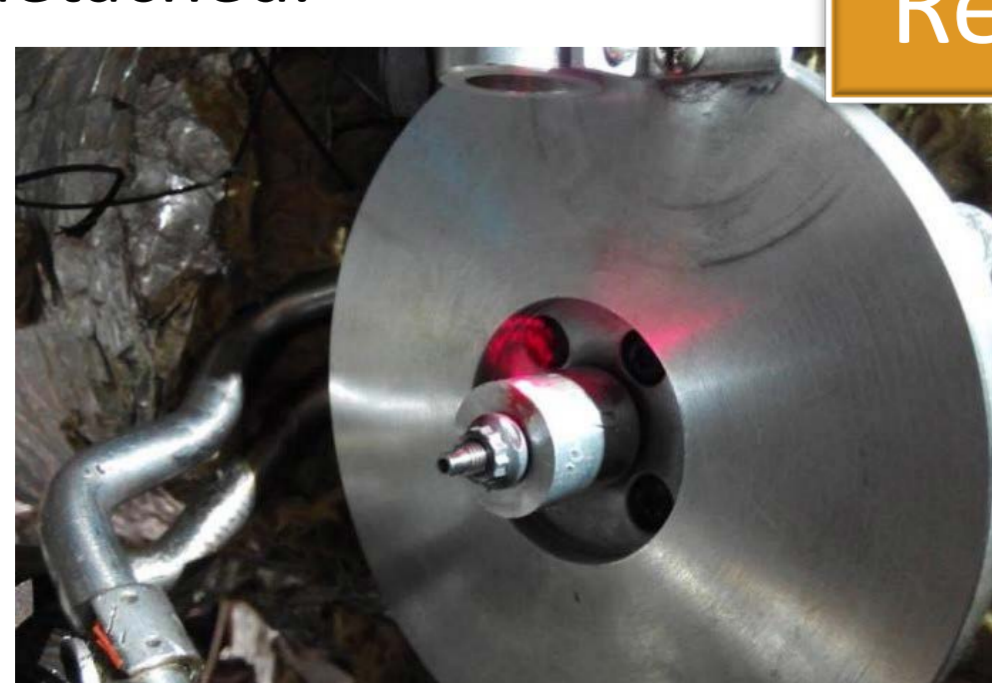
rpm
5830 & 6715
K^{0.5}

To gain beneficial results for two remaining speeds the point close to zero mechanical efficiency has been measured ($W_{comp.} = 0$). The compressor wheel and its casing have been detached.

Limitation: Rising the rotational speed, the lubrication film has broken down while expanding to the ambient pressure. At this condition a huge amount of oil is sucked through the compressor to the surrounding and metal to metal contact occurs, destructing the turbocharger.
