# Is traditional earthen architecture common in Aragón?

This work is part of the research project "Restoration and rehabilitation of traditional earthen architecture in the Iberian Peninsula. Guidelines and tools for a sustainable intervention", funded by the Spanish Ministry of Science and Innovation (Ref.: BIA2014-55924-R; main researchers: Camilla Miletto and Fernando Vegas).

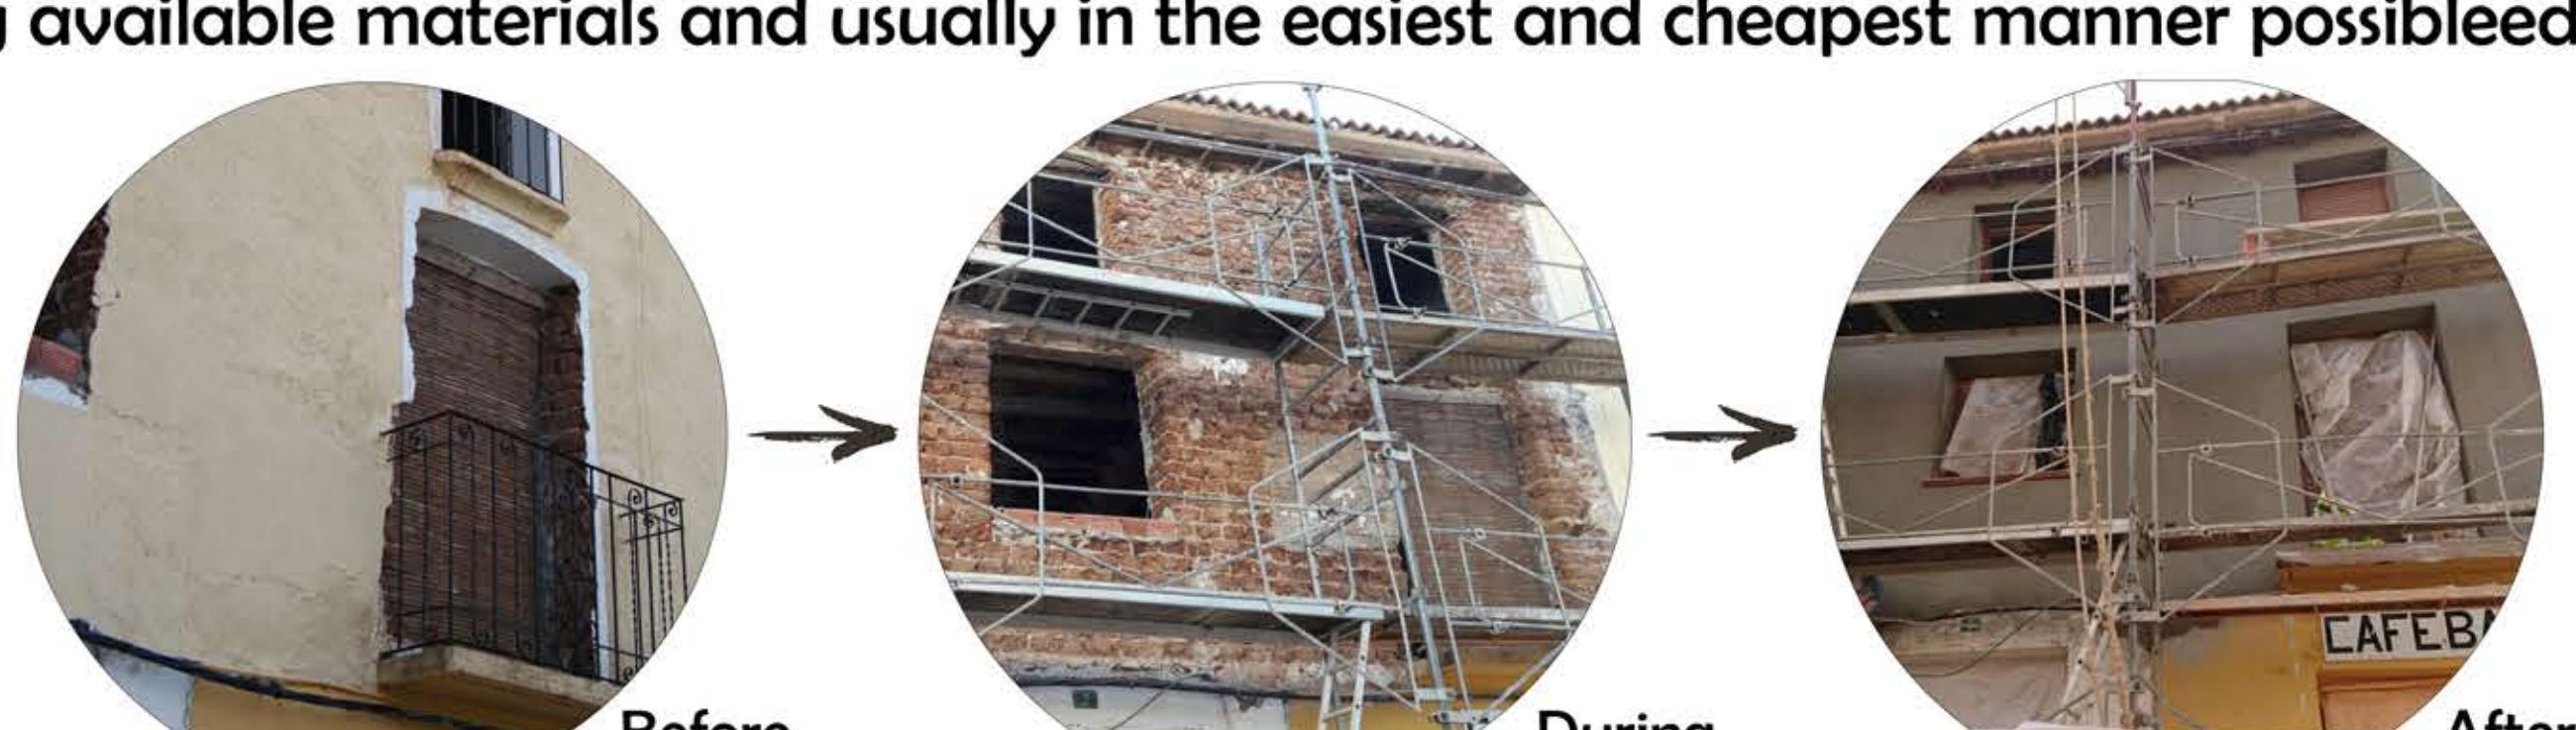
- A large number of buildings have not been subject to interventions, being part of the in a really bad conservation state or ruins.
- Buildings in use have mostly undergone interventions. Those interventions are usually immediate spontaneous responses to maintenance or repair issues in the quickest way using available materials and usually in the easiest and cheapest manner possible.
